CASE STUDY

CERTA-LOK® PVC PIPE OFFERS TWO-DAY AERIAL INSTALLATION FOR MUCH-NEEDED POTABLE WATER DELIVERY

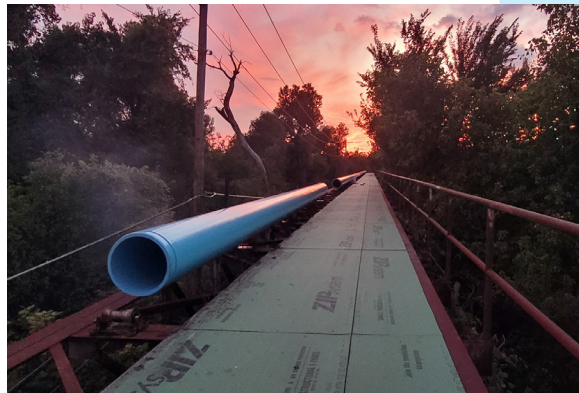
In February of 2021, an 18-inch steel water pipeline installed along a 600-foot aerial crossing over the North Canadian River suffered a number of cracks during a fierce snowstorm. The cracks put the water line out of service until repairs could be started that summer. Water delivery to the west side of town was still possible with the line out of operation, but it was less than ideal. Summer arrived and the repair process was underway. With the old steel pipe pressurized, the team identified the location of the leaks. The pipe was then de-pressurized to install the first clamp and re-pressurized to test the repair. Using this process, seven repair clamps were installed to the aerial line with the pipe continuing to leak, at this point it was decided no further restoration attempts would be made. The city moved forward with approving a project to replace the damaged line and Project WC-1022 was scheduled for the 2023 construction season. The new design outlined installation of the pipeline under the North Canadian River instead of replacing the line in the same aerial position, over the river, exposed to the elements. There was still a need to address the current water demand and the team reviewed an immediate and speedy solution for an emergency repair.

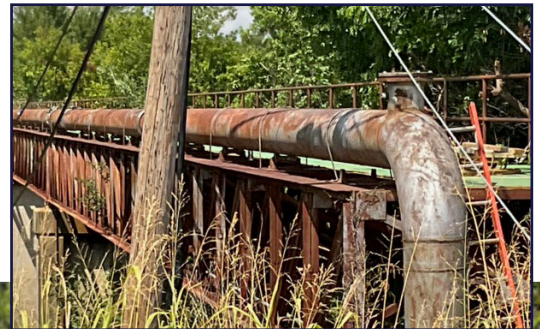
ORIGINAL STEEL WATER PIPELINE

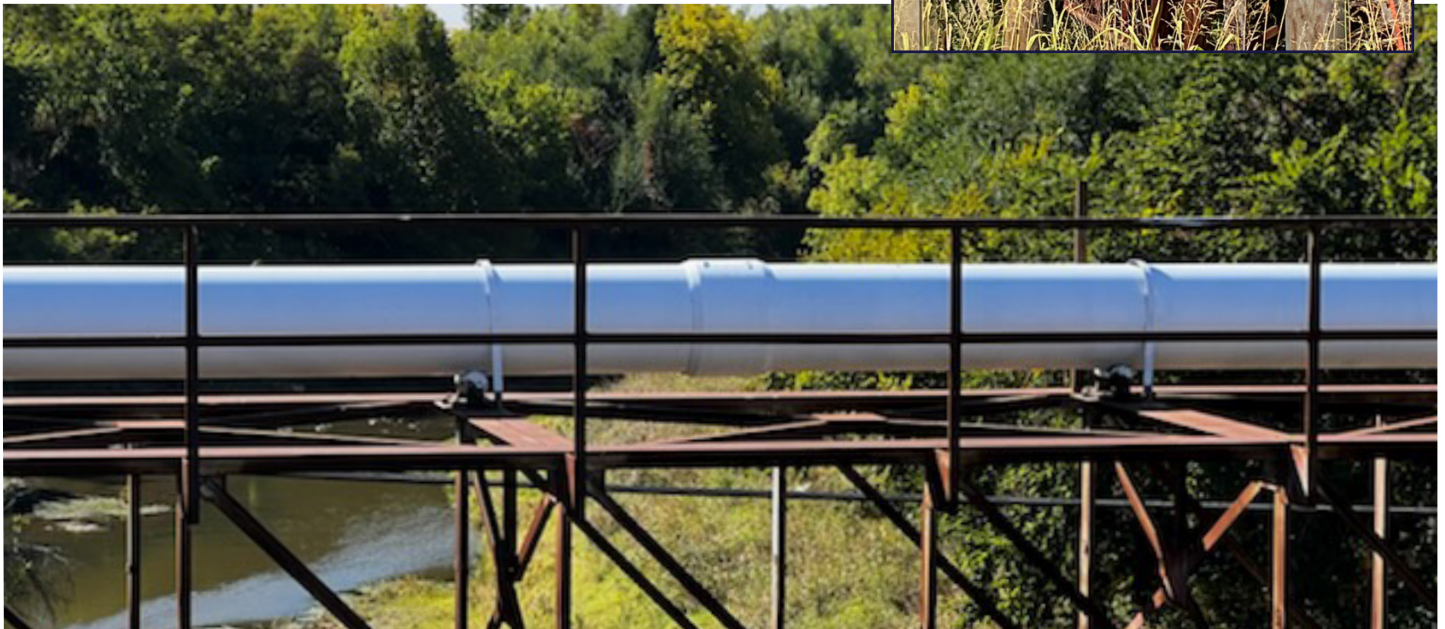
**AFTER – 18” CERTA-LOK® FINISHED INSTALLATION
SHOWN HERE PAINTED FOR UV PROTECTION**

The simplicity of Wade Vakulick’s plan resulted in the 600 feet of pipe being installed in less than two days. The crew started swinging the new pipe onto the bridge in the afternoon and finished the following morning. Once all the pipe was in place, the workers manually assembled the pipe-to-coupling joints. Finally, the nylon spline was inserted into the spline insertion holes completing the “spline lock” and the joint was fully restrained.
