# LIFE CYCLE ASSESSMENT OF PVC WATER AND SEWER PIPE AND COMPARATIVE SUSTAINABILITY ANALYSIS OF PIPE MATERIALS

This study evaluates underground pipe infrastructure in the context of providing sustainable water and sewer service over a 100-year period: (1) with minimal risk of degrading water quality; (2) while reducing the costs of operations, maintenance and repair; and (3) by taking into consideration the variables which can influence pipe performance and service-level expectations. The report also provides relevant data which can assist utility officials with their asset management plans and life cycle cost assessments for different pipe materials.

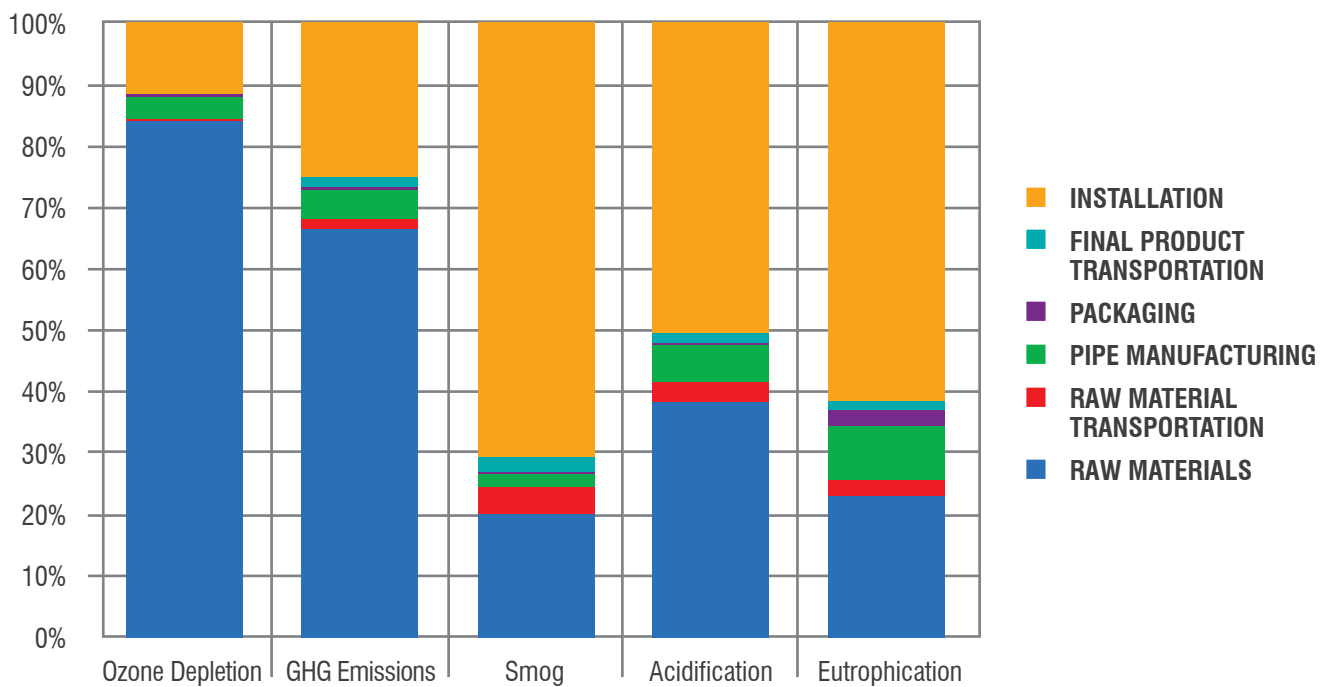
**FIGURE 4.3 : ENVIRONMENTAL IMPACTS OF 8" PVC DR25 PC165 C900 PRESSURE PIPE (TRACI IMPACT ASSESSMENT METHODOLOGY)**

- INSTALLATION
- FINAL PRODUCT TRANSPORTATION
- PACKAGING
- PIPE MANUFACTURING
- RAW MATERIAL TRANSPORTATION
- RAW MATERIALS

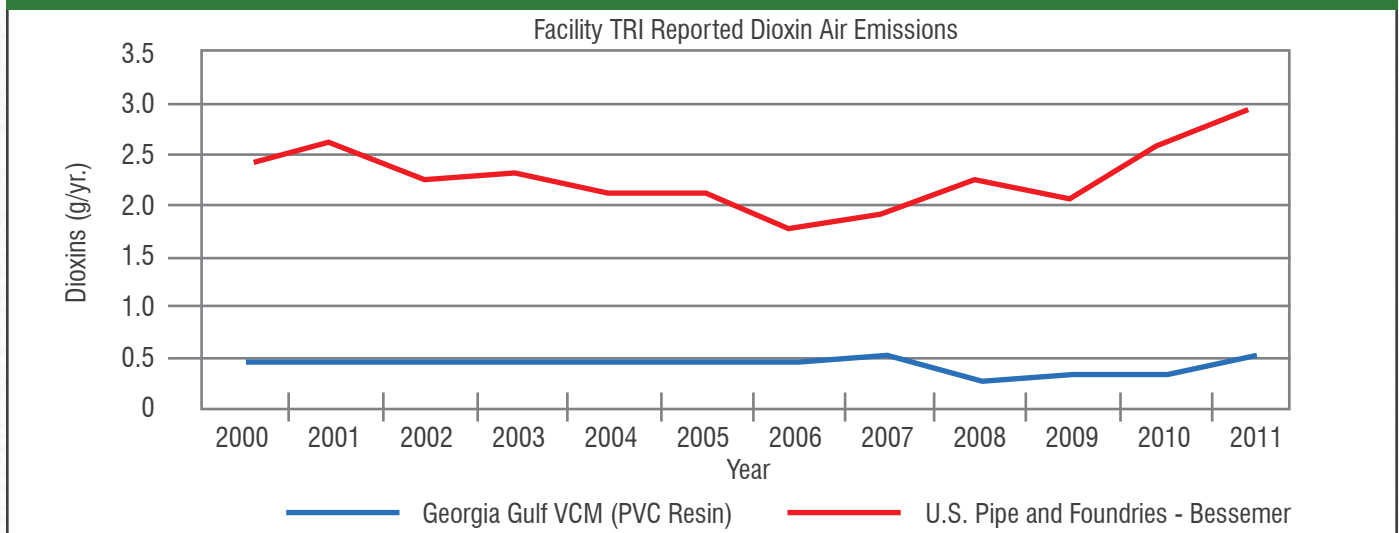
**FIGURE 5.2 : ANNUAL DIOXIN AIR EMISSIONS FROM A VCM PVC RESIN PLANT AND A DUCTILE IRON PIPE PLANT TO THE U.S. EPA TOXIC RELEASE INVENTORY**

Dioxin emissions are tracked by the U.S. EPA through the Toxic Release Inventory (TRI). TRI data are made publicly available. Figure 5.2 is a sampling of the dioxin air emissions reported by a VCM (PVC resin) manufacturer and a ductile iron manufacturer.<sup>35</sup>

- ▶ U.S. EPA data show that dioxin emissions released from a ductile iron foundry were almost six times as high as a facility producing PVC resin.
- ▶ PVC pipe manufacturing facilities do not emit dioxins.

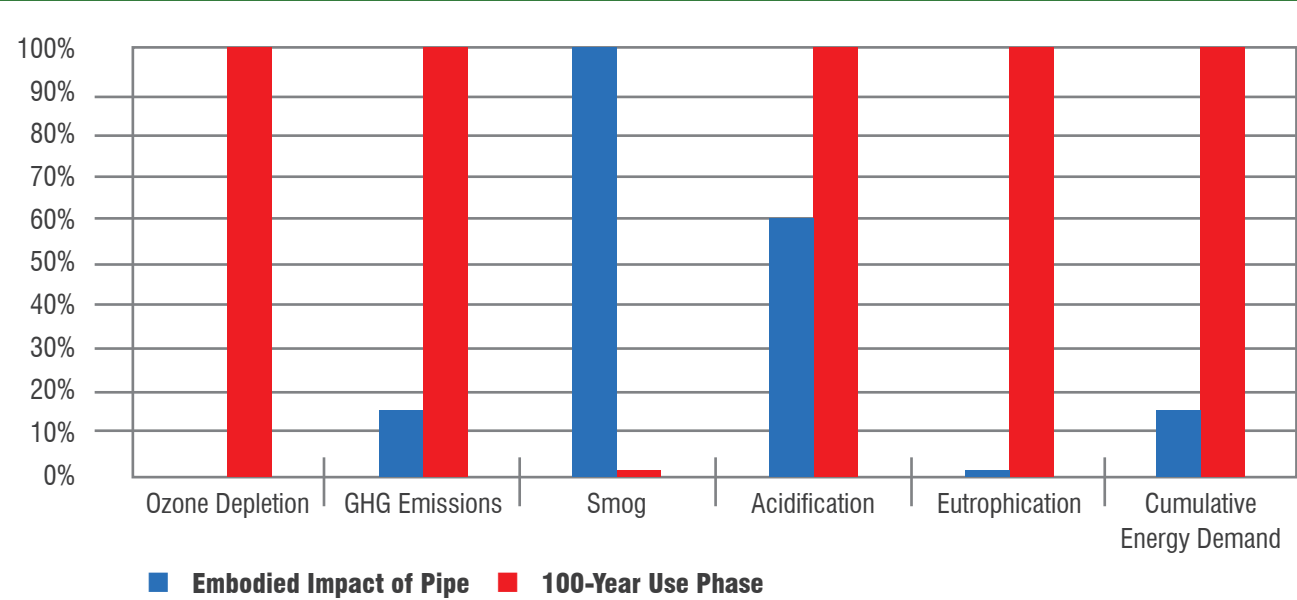
FIGURE 7.1 : ENVIRONMENTAL IMPACTS OF THE USE PHASE OF 8” PVC DR25 PC165 C900 PIPE VS. EMBODIED IMPACTS OF THE PIPE

The use phase of the pipe life cycle dominates as the primary cause of environmental impacts of PVC pipe with the exception of smog which is primarily caused by production of electricity and burning of fuel in the pipe installation equipment and from raw materials extraction and production.

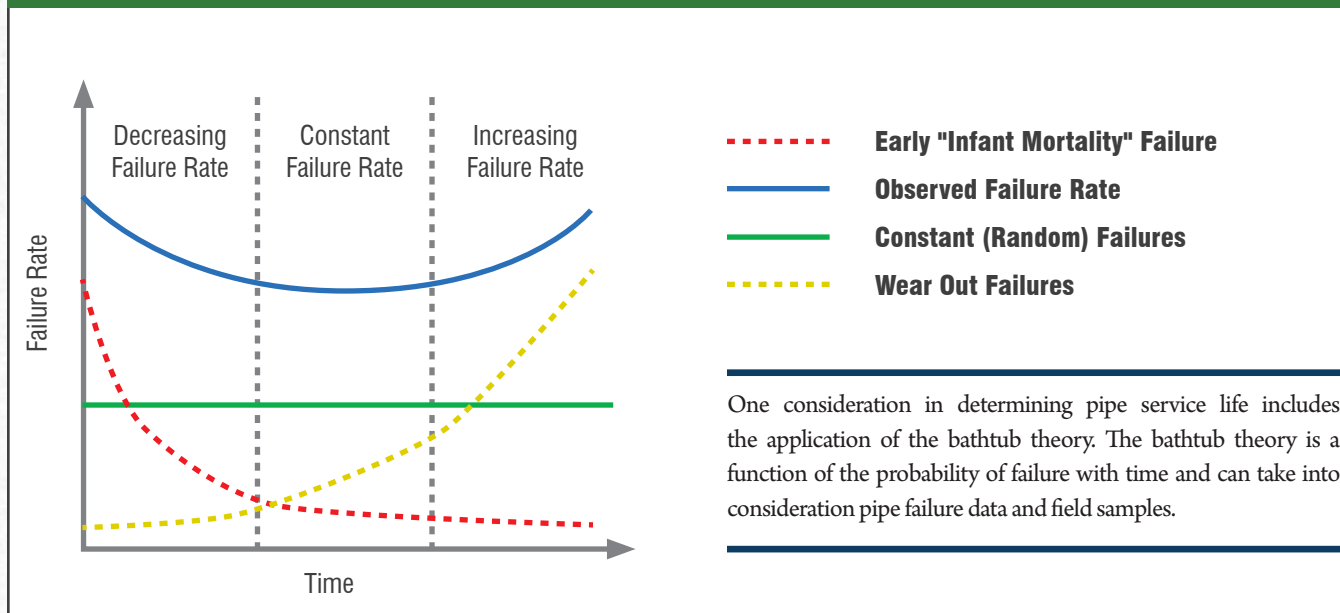
**FIGURE 8.1 : APPLYING THE “BATHTUB” THEORY TO DETERMINING PIPE SERVICE LIFE**

Another component of determining a service life is to assign a value to the various pipe materials for comparison purposes, which includes going beyond manufacturers' marketing claims and reviewing additional sources to better understand the expected service level of a pipe. The combination of performance and service delivery are critical in order to assign a value.<sup>61</sup> This takes into consideration when water main breaks begin to occur, water quality issues arise, or pipe degradation (internal and/or external) is a concern and needing attention. In these circumstances the pipe has effectively met its service life as a low cost managed asset and now its total life cycle cost or total cost of ownership will begin to drastically increase.

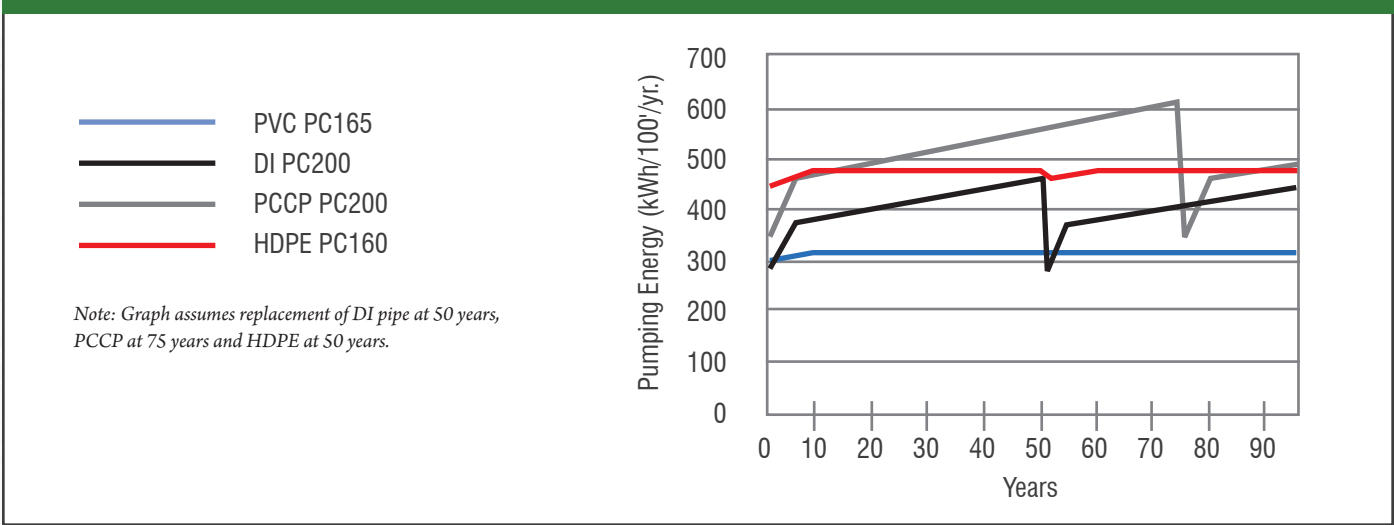
**FIGURE 8.4 : ANNUAL PUMPING ENERGY COMPARISONS FOR 24" PIPES**

Since PVC pipe does not corrode as it ages, the smoothness of the internal pipe wall surface does not decrease. PVC pipe has a smooth surface which reduces frictional energy loss over the pipe's life compared to metallic or concrete pipes. The Hazen-Williams coefficient (C factor) for new PVC pipe is 155-165 (the higher the value, the smoother the pipe).<sup>87</sup> A flow coefficient of  $C = 150$  is generally used as a conservative value for the design of PVC piping systems.<sup>88 89 90</sup> In contrast, new mortar-lined ductile iron pipes can have a C factor of 140 as claimed by the Ductile Iron Pipe Research Association (DIPRA). However, due to corrosion and deterioration of the lining material, the internal walls of iron pipes become significantly rougher over time, decreasing the C factor.<sup>91</sup> To prevent corrosion and provide a pipe wall that is listed for contact with potable water, cement lining is added to ductile iron water pipes. Concrete pipes and cement-mortar lined metallic pipes' C factors typically range from 120-140 for new pipe and 75-100 for older pipe as it degrades over time.<sup>92</sup> Field samples of over 60 mortar-lined

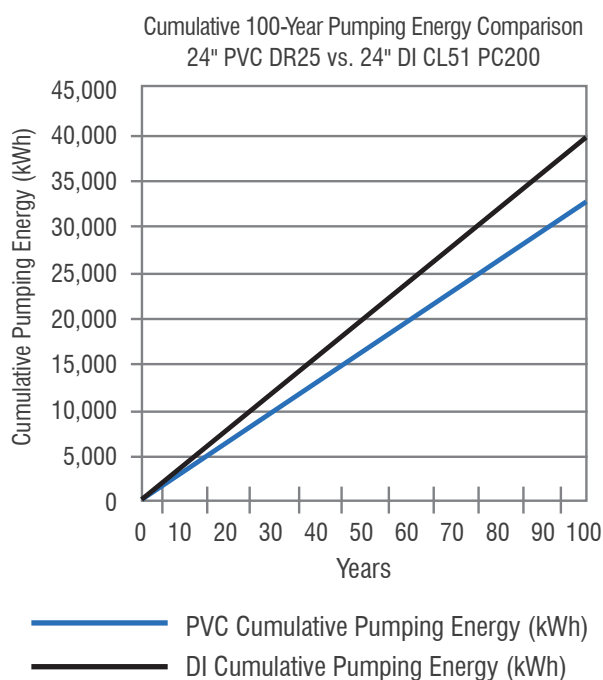
**FIGURE 9.2 : COMPARISON OF CUMULATIVE 100-YEAR PUMPING ENERGY FOR 24" PVC AND DI PIPE**

Note: Graph assumes replacement of DI pipe at 50 years.

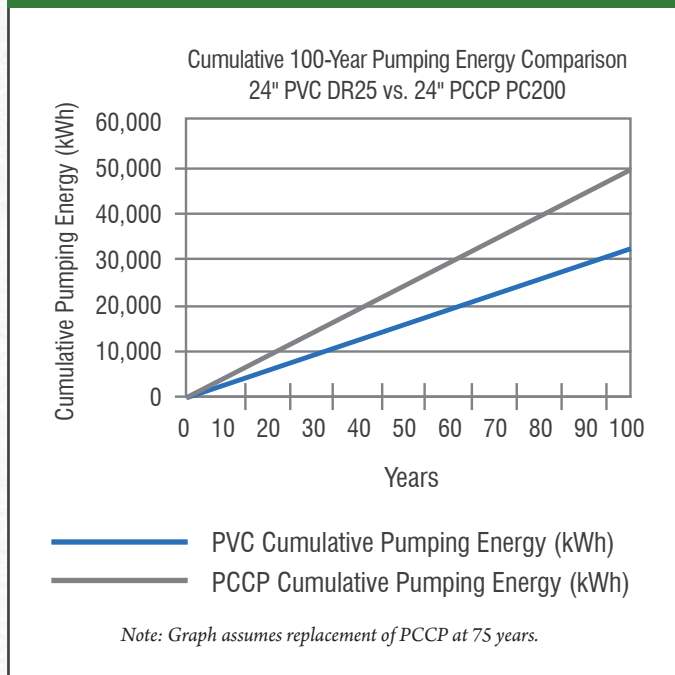
**FIGURE 9.5 : COMPARISON OF CUMULATIVE 100-YEAR PUMPING ENERGY FOR 24" PVC AND PCCP**

Note: Graph assumes replacement of PCCP at 75 years.

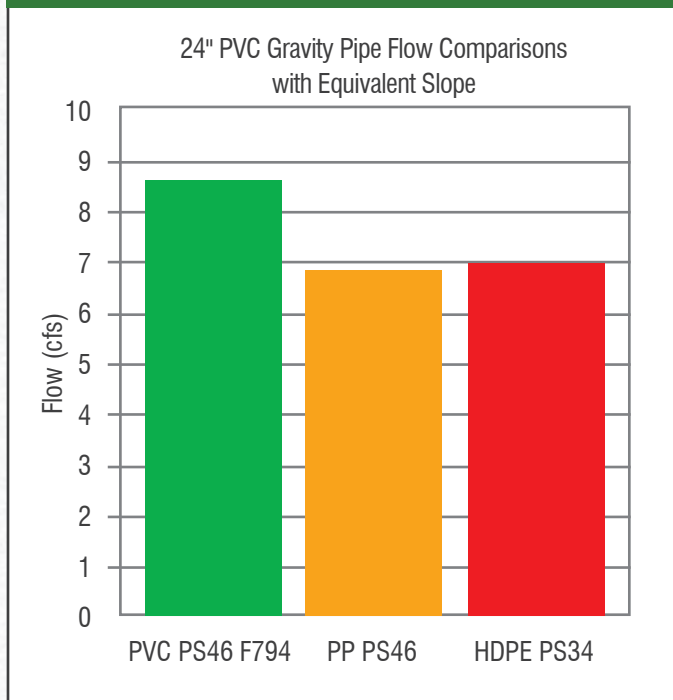
**FIGURE 9.7 : FLOW COMPARISON WITH EQUIVALENT SLOPE OF 24" PVC, PP AND HDPE PROFILE-WALL PIPES**

HDPE and PP pipes are subject to strain creep. Strain creep is a property of some materials whereby, when subjected to a load, the pipe will continue to slowly flex under the load over time. For buried HDPE and PP gravity pipes, strain creep means that the pipes will continue to deflect over time. The standards for HDPE and PP gravity pipes make allowances for strain creep over the expected lifetime of the pipes.

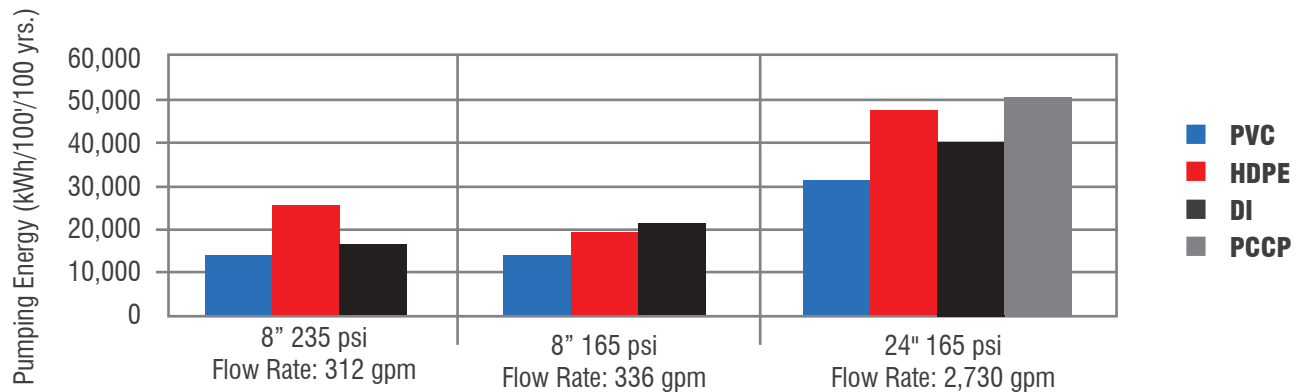
**FIGURE 10.1 : COMPARISON OF TOTAL 100-YEAR PUMPING ENERGY USE PER 100 FEET OF PIPE**

Note: Graph assumes replacement of HDPE pipe at 50 years, DI pipe at 50 years and PCCP at 75 years.

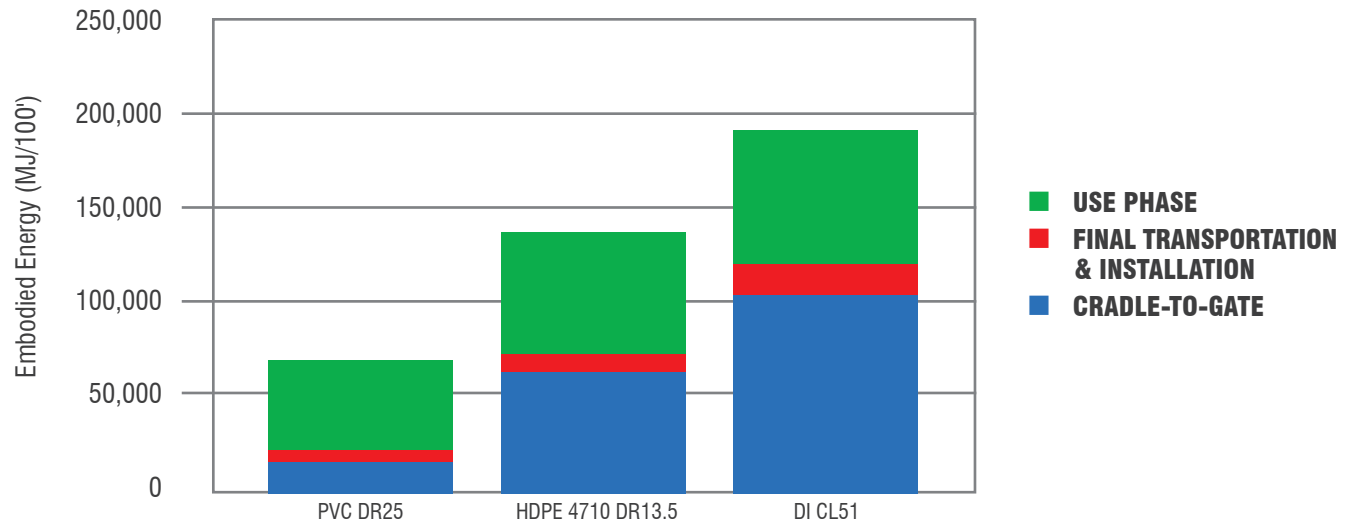
**FIGURE 12.2 : TOTAL 100-YEAR EMBODIED ENERGY FOR 8" PVC DR25 EQUIVALENT PRESSURE PIPES**

Figure 12.2 compares 8-inch PVC, HDPE and DI pipes with a pressure class at or equivalent to PVC DR25 PC165. As demonstrated, the total 100-year embodied energy for PVC pipe is 52 percent less than HDPE and 56 percent less than DI pipes.

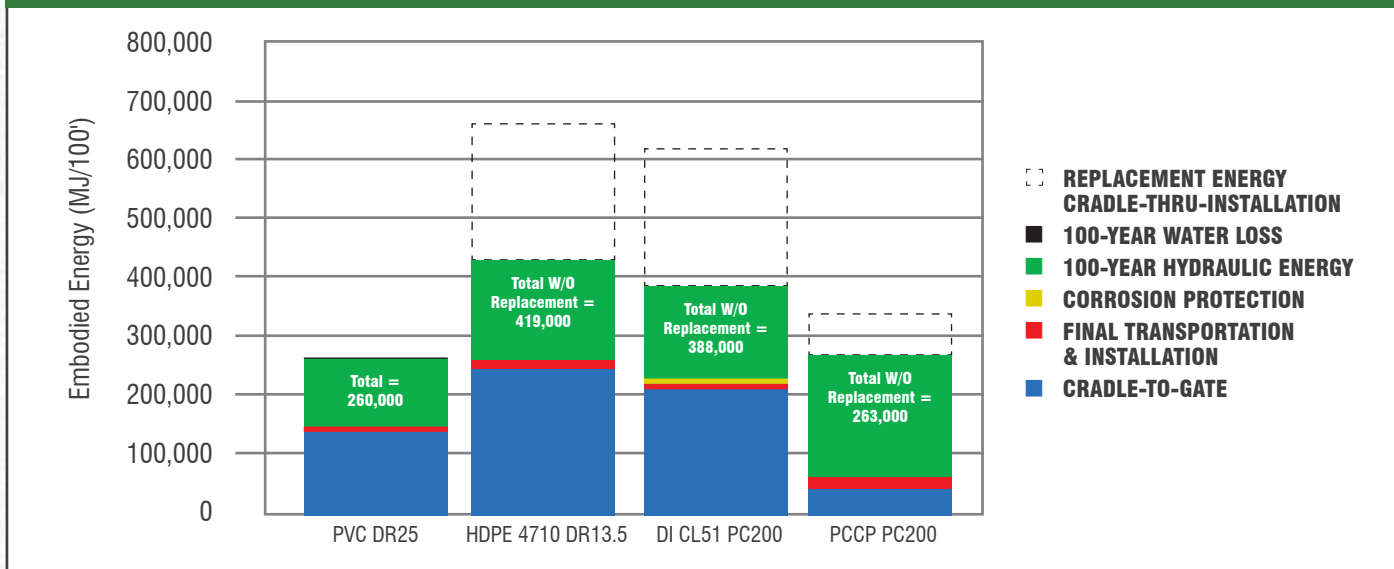
**FIGURE 12.4 : TOTAL 100-YEAR EMBODIED ENERGY FOR 24" PVC DR25 EQUIVALENT PRESSURE PIPES  
(HYDRAULIC ENERGY WITHOUT REPLACEMENT)**

Manufacturers of HDPE, DI and PCCP pressure pipes may claim that their pipes should not be replaced during the 100-year system design life and that this study unfairly represents their products. However, this study has demonstrated that these pipe products need replacement within 50 years. Moreover, even without replacement these pipe materials still have greater total embodied energy over 100 years than PVC pipe.

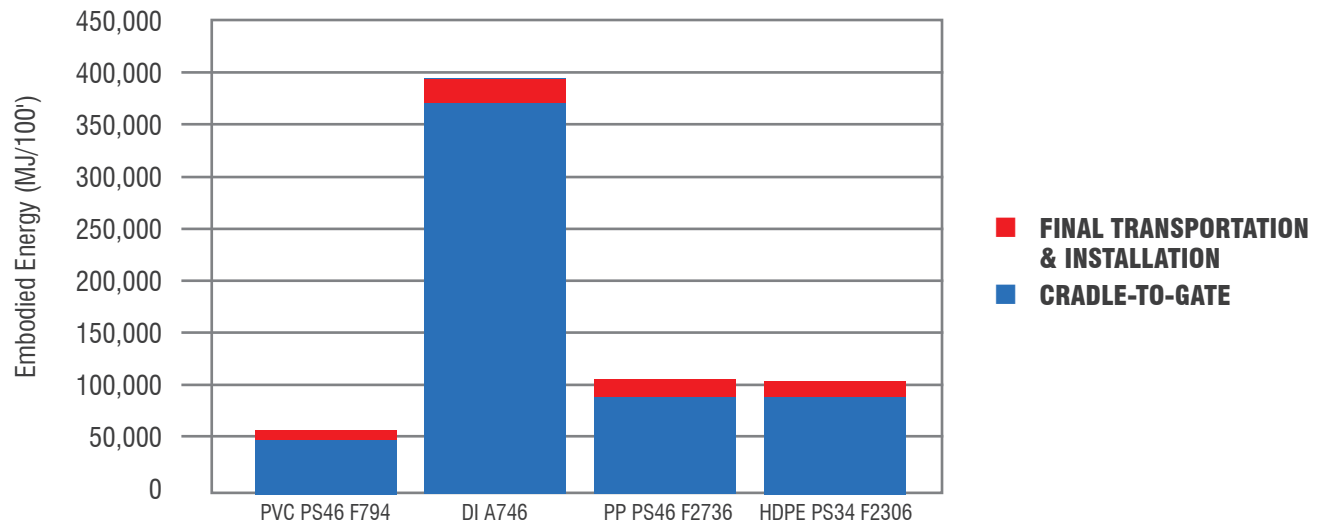
**FIGURE 12.7 : TOTAL 100-YEAR EMBODIED ENERGY FOR 24" PVC PS46 F794 PROFILE-WALL EQUIVALENT GRAVITY PIPES**

Figure 12.7 compares 24-inch PVC profile-wall, DI, PP and HDPE pipes equivalent to PVC PS46 F794 profile-wall pipe. The total 100-year embodied energy of PVC sewer pipe is 85 percent less than equivalent DI sewer pipe; 44 percent less than PP and 43 percent less than HDPE sewer pipes. It should be noted that the equivalent HDPE sewer pipe has a pipe stiffness that is 26 percent less than the pipe stiffness of PVC pipe.

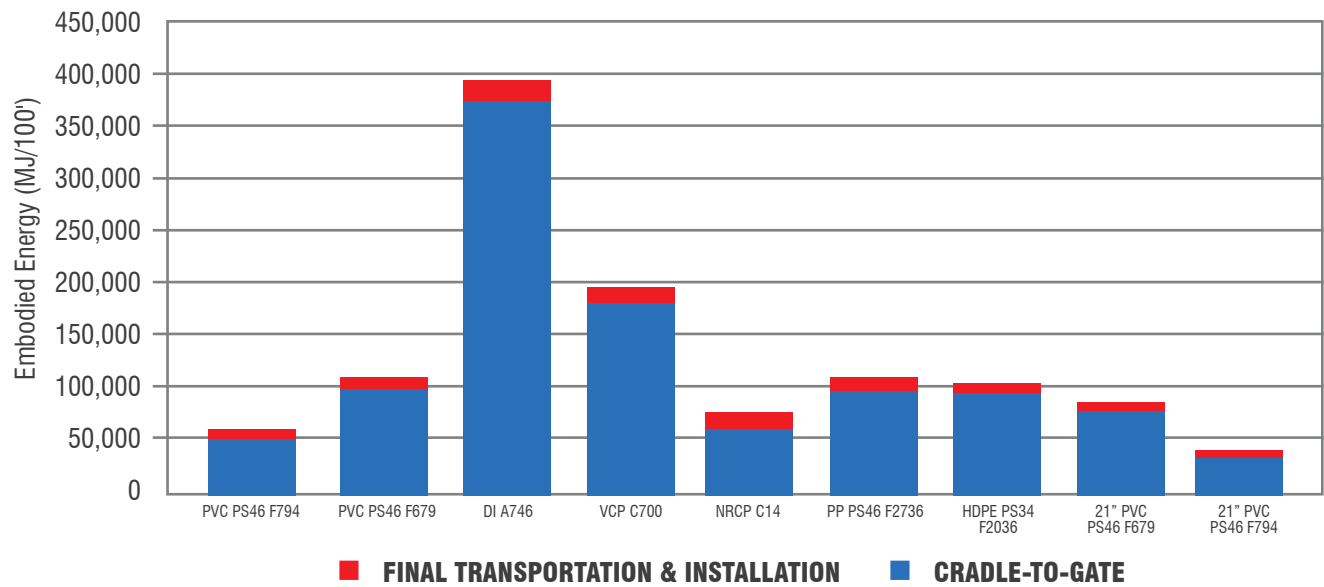
**FIGURE 12.9 : TOTAL 100-YEAR EMBODIED ENERGY FOR 24" PVC PS46 SOLID-WALL & PROFILE-WALL EQUIVALENT GRAVITY PIPES**

PVC has greater embodied energy compared to NRCP pipe, but NRCP is highly susceptible to deterioration from gases produced by wastewater. Due to this deterioration, NRCP would likely be required to be replaced two or more times during a 100-year design life for the pipe system. The corrosion of the pipe wall would also lead to increased infiltration and possibly pipe collapse. Increased infiltration significantly increases energy requirements and costs of a wastewater system. A pipe collapse not only requires large costs to repair, but could cause significant environmental contamination and endanger the safety of the public by undermining the support structure for buildings and roads built near sewer lines.

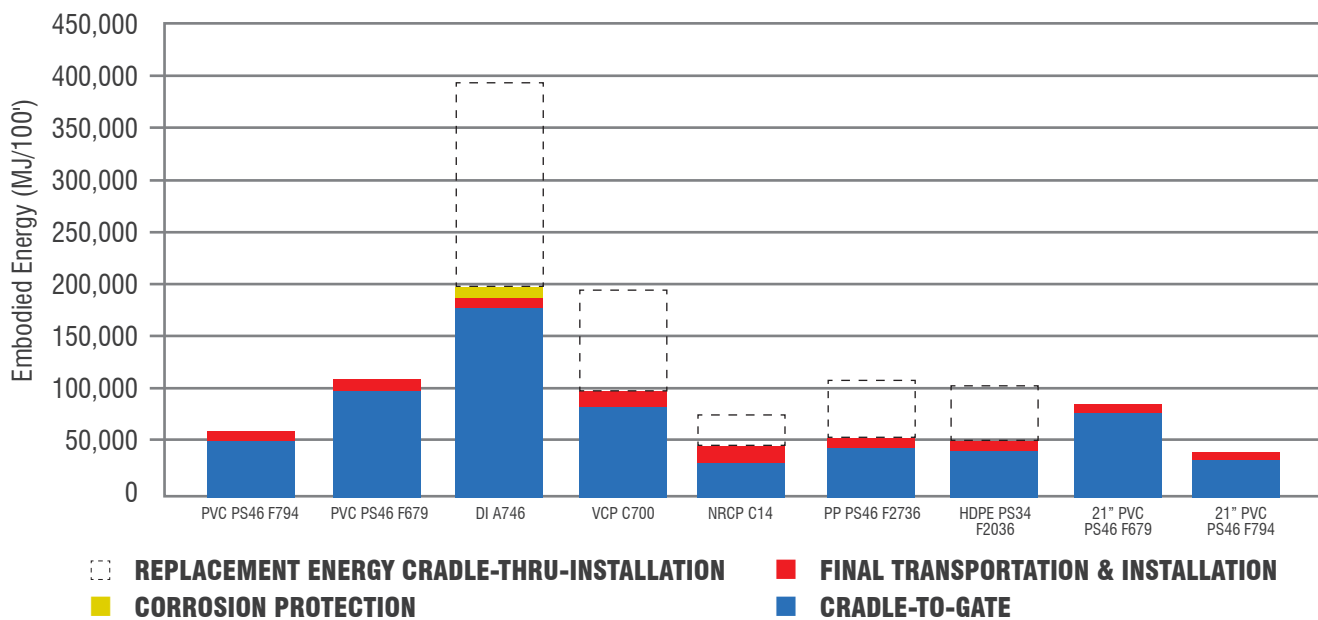
**FIGURE 12.10 : TOTAL 100-YEAR EMBODIED ENERGY FOR 24" PVC PS46 SOLID-WALL & PROFILE-WALL EQUIVALENT GRAVITY PIPES**

In order to be transparent, Figure 12.10 highlights the differences in embodied energy among the 24-inch gravity pipes without the needed replacements during the 100-year design life. Examination of Figure 12.10 reveals that 24-inch DI, VCP, PP and HDPE pipes have higher or equivalent 100-year embodied energies than PVC pipes even when replacement embodied energies are not considered.
